DAM SECTION A

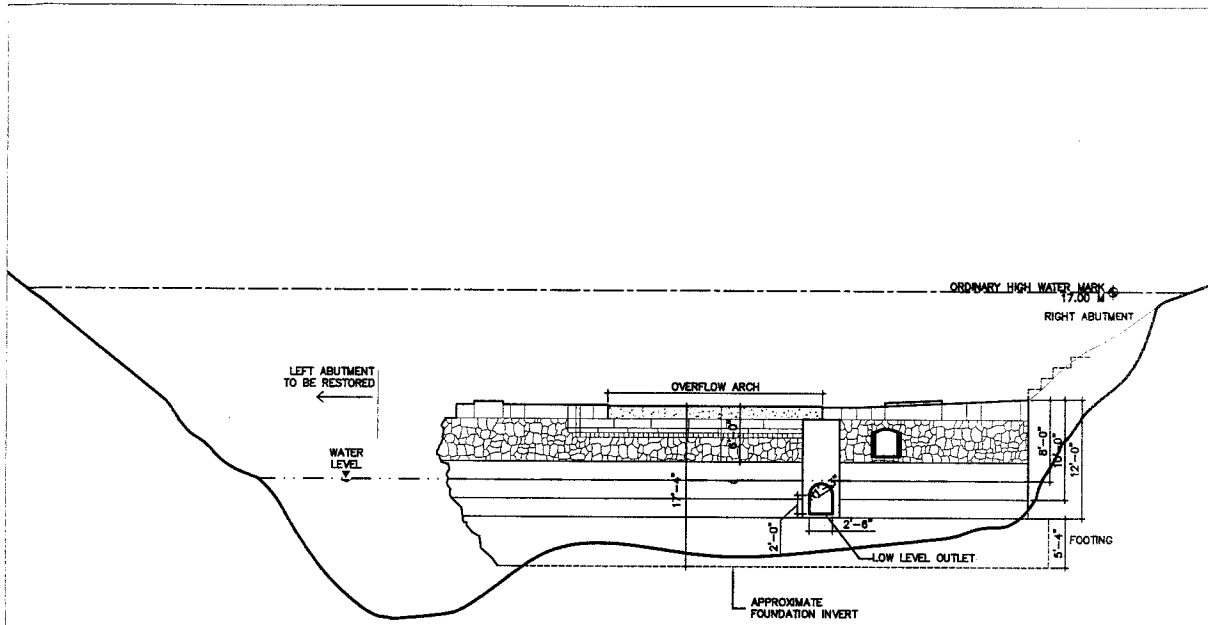
**EXISTING CONDITION
UPSTREAM ELEVATION**

1. THE LOW-HEAD DAM HAS BEEN DAMAGED BY STREAMFLOWS AND IS CURRENTLY DISPLACED BOTH HORIZONTALLY AND VERTICALLY. IT WILL BE RESTORED AS CLOSE AS POSSIBLE TO ITS ORIGINAL CONDITIONS.

2. THE LEFT ABUTMENT HAS BEEN WASHED AWAY BY STREAMFLOWS AND THE STREAM IS CURRENTLY FLOWING THROUGH THIS SIDE OF THE RIVER. THIS ABUTMENT WILL BE RESTORED AND PROVIDED WITH A CONCRETE PLUG/WALL TO MINIMIZE THE CHANCE OF OCCURRING AGAIN. THE CHANNEL SLOPE WILL BE LINED WITH RIP/RAP OR AN APPROPRIATE LAYER FOR STABILITY.

6. THE LOW LEVEL OUTLET WILL BE RESTORED AND WILL SERVE ALSO AS THE FISHWAY WATER OUTLET AND FISH ENTRANCE.
7. THE UPSTREAM POOL IS CURRENTLY EMPTY AS A RESULT OF THE MIGRATION OF THE STREAM AROUND THE DAM THROUGH THE LEFT ABUTMENT. THE UPSTREAM POOL WILL BE RESTORED WHEN THE RESTORATION WORKS ARE COMPLETED.

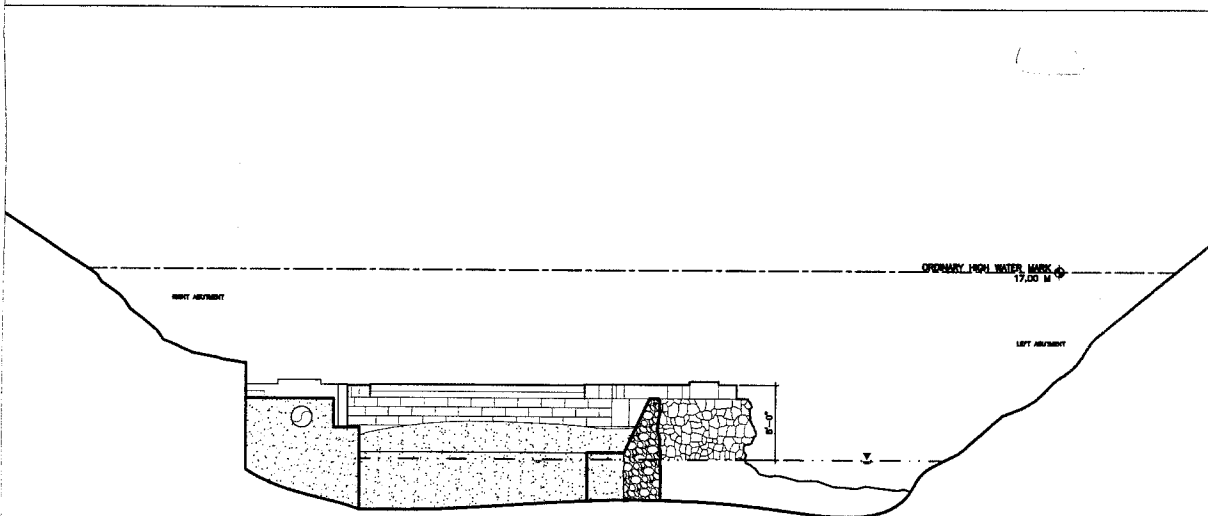
**EXISTING CONDITION
DOWNSTREAM ELEVATION**

3. THE DOWNSTREAM RIGHT ABUTMENT IS IN GOOD CONDITIONS AND WE DO NOT ANTICIPATE RESTORATION WORKS ON THIS AREA. PLEASE SEE NOTE #4.
4. THE DIVERSION TUNNEL/PIPE HAS BEEN PARTIALLY DAMAGED IN THE AREAS NEAR THE DAM STRUCTURE AND WILL BE RESTORED AS CLOSE AS POSSIBLE TO ITS ORIGINAL CONDITIONS.

5. ORIGINAL DESIGN ILLUSTRATES A SUBMERGED CONCRETE WALL/BEAM DOWNSTREAM THE DAM. THIS BEAM PRESUMABLY DEFINED THE LIMITS OF THE STILLING BASIN DOWNSTREAM THE DAM AND WILL BE RESTORED AS REQUIRED. THE STILLING BASIN WILL BE PROVIDED WITH BURIED RIP RAP.
